U.S. 101 MP 100.70 Unnamed Tributary (WDFW ID 990730): Preliminary Hydraulic Design Report

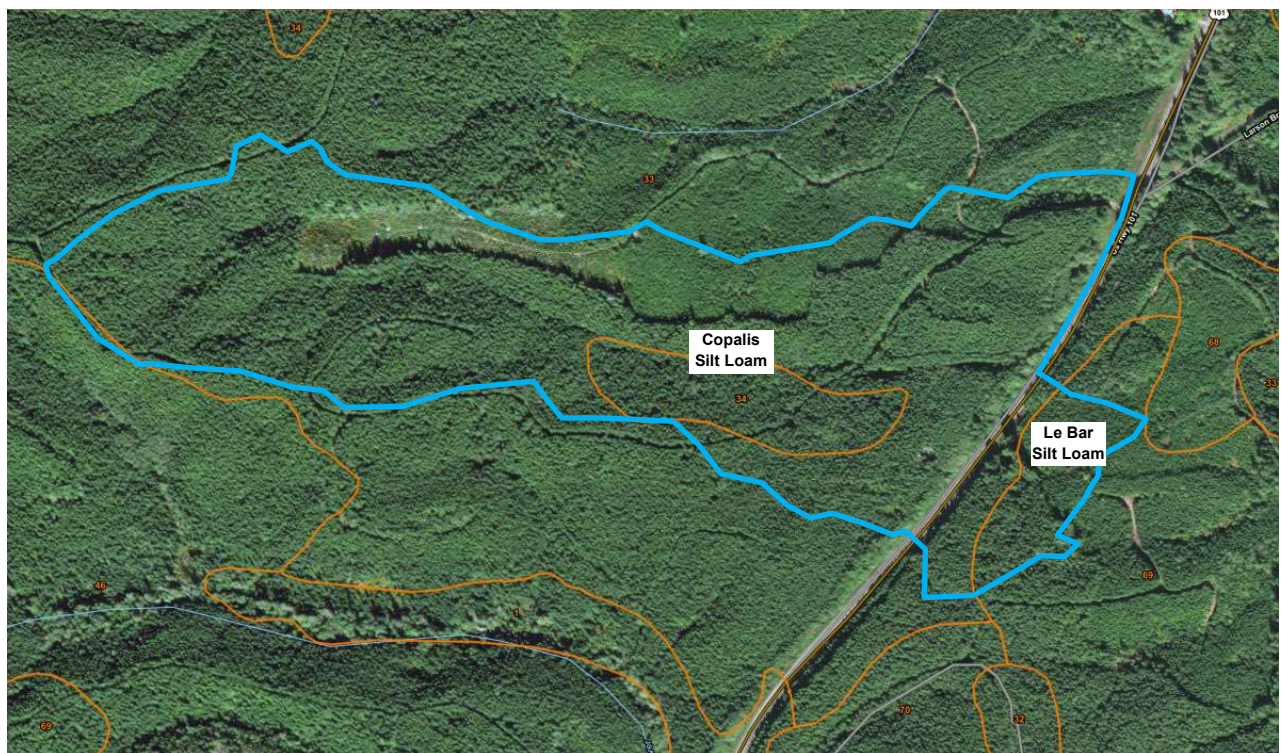
Figure 3: Soils map (NRCS Soil Survey Website). An approximate catchment area upstream of the culvert is depicted

No indicators of landslide activity were observed during the July 13, 2021 field visit. A boundary search conducted August 2021 of the DNR landslide inventories and hazards (Washington Geological Survey, 2020a and 2020b) identified no landslide studies or landslide hazards within the watershed. The watershed's hillslopes are composed almost exclusively of Copalis and Le Bar soil types, which consist of moderately to highly erodible silt loams (Figure 3; NRCS web soil survey).

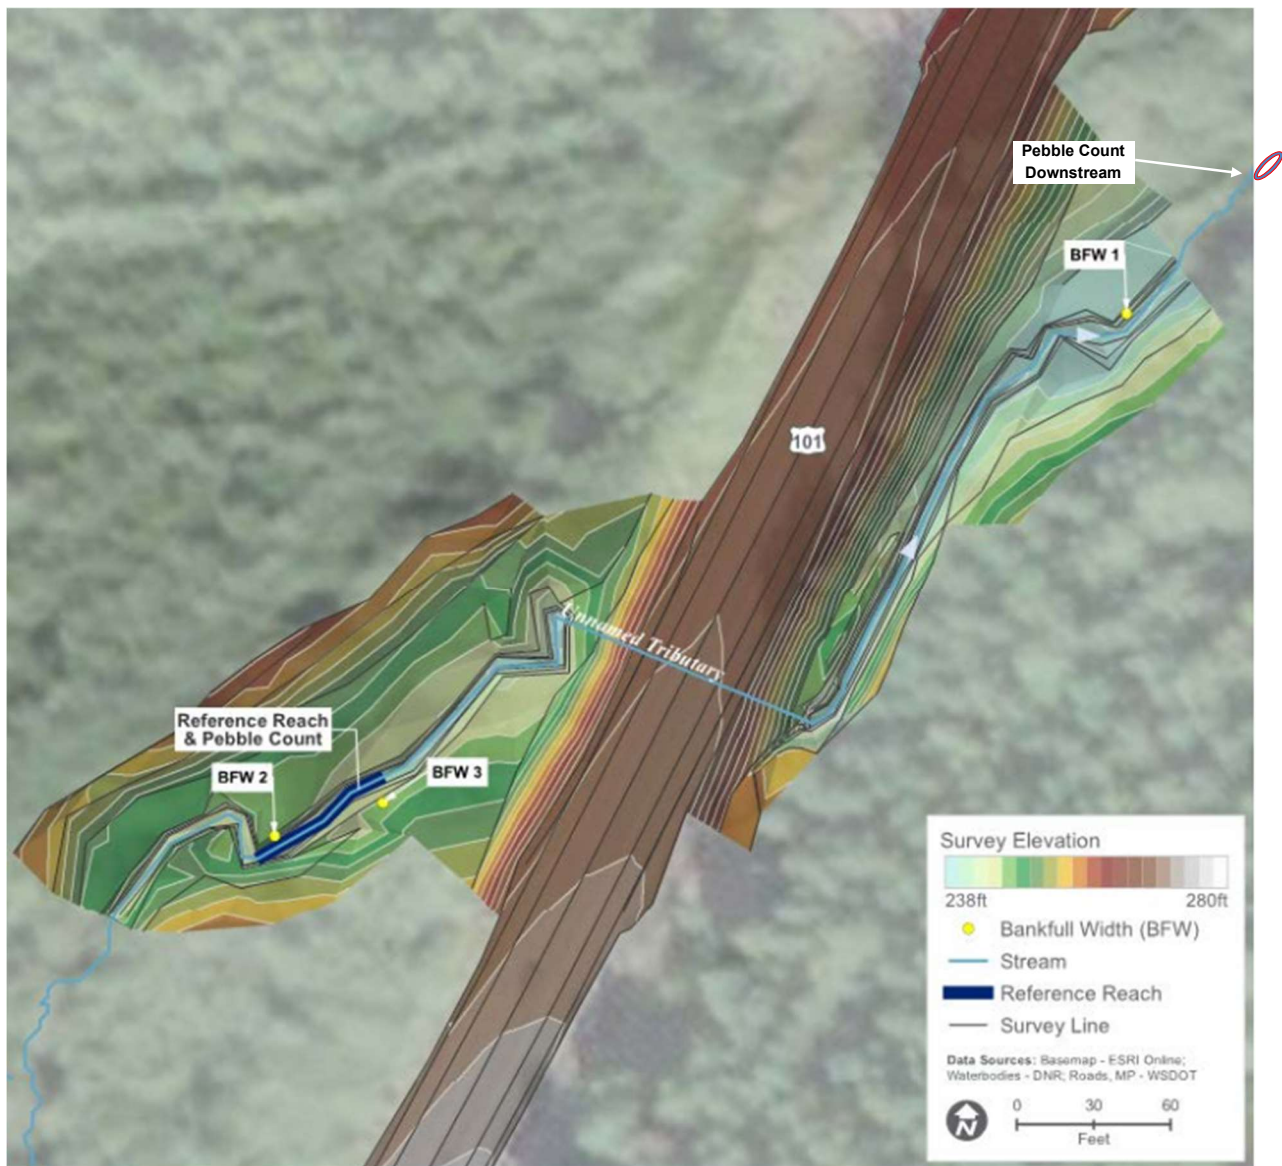
Figure 19: Reference reach and locations of BFW measurements and substrate sampling

A reach starting approximately 130 feet upstream of the culvert (Figure 19) was selected as most representative of the natural stream channel with the least anthropogenic influence, and is situated in line with the larger scale reach grade (see Section 2.8.4). The reference reach was relied on primarily for measuring bankfull dimensions for informing the design of the hydraulic opening width and the cross-section morphology of the constructed channel outside of the replacement structure footprint. The reference reach morphology was not used to design cross-section shape and planform underneath the replacement structure because vegetation controlling bank stability cannot generally grow there.

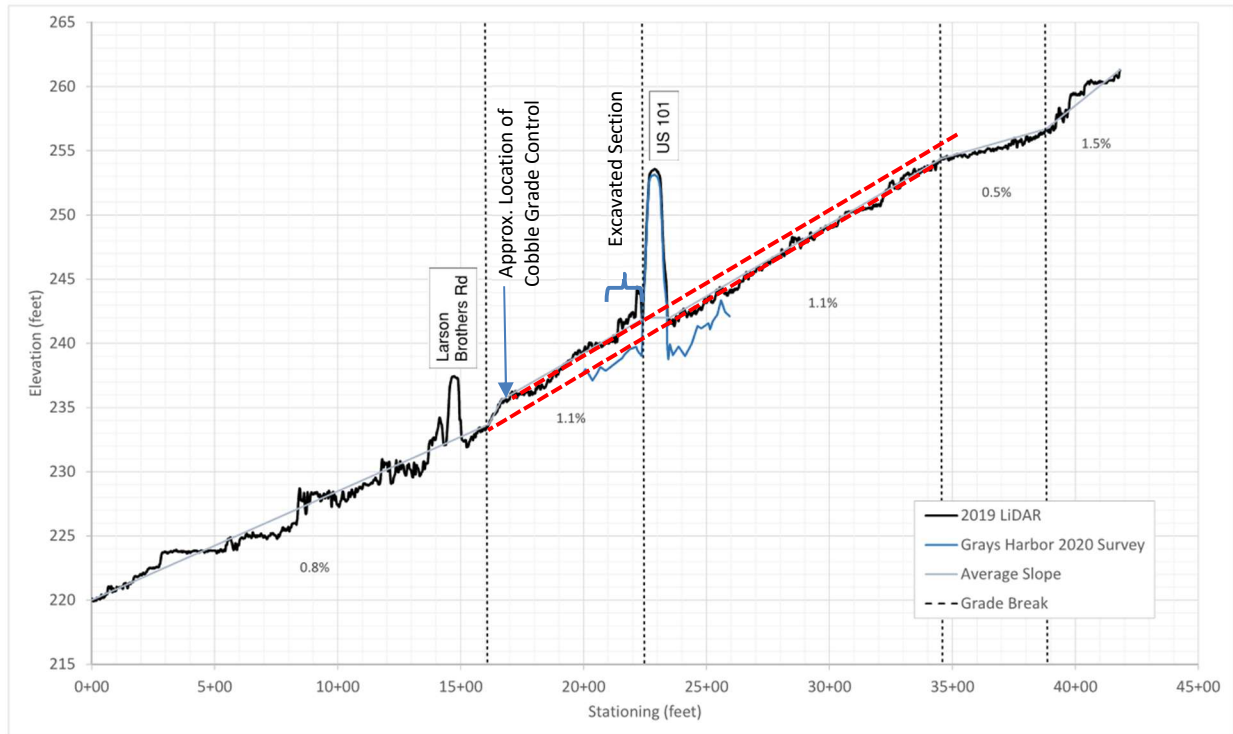
Figure 24: Watershed-scale longitudinal profile (NAVD88 datum); Red dashed lines indicate approximately parallel reach scale grades upstream and downstream of US 101 that were offset by construction of the existing culvert

The maximum extent of aggradation and degradation that are expected over an engineering timescale depends on the relative rates of the two processes. Our assumption is that land use in the watershed caused rates of aggradation greater than what we would expect in the future, for several reasons. First, the potential of landslides or debris flow type sediment delivery is low in the watershed given the prevailing relief. Historical clearcut logging including within the riparian zone likely created spikes in sediment supply and increased runoff greater than would be expected in the future after the 2005 change in forest practices rules. Despite these extremes, we see no physical field evidence of large-scale aggradation or degradation within the observed reach, and there are various buried log steps in the channel that help maintain grade in addition to the cobble section downstream. The cobble grade control downstream provides mitigation against larger-scale degradation overall.

And, noting that the proposed culvert is not significantly longer than the existing culvert, realignment of the stream channel back to its likely historic course can be projected to shorten the profile in Figure 24 by about the length of the excavated section. The essentially parallel grades upstream of the cobble grade control and above US 101 depicted in Figure 24 then become approximately superimposed on each other, indicating that the overall grade has remained stable despite the historic realignment that occurred.

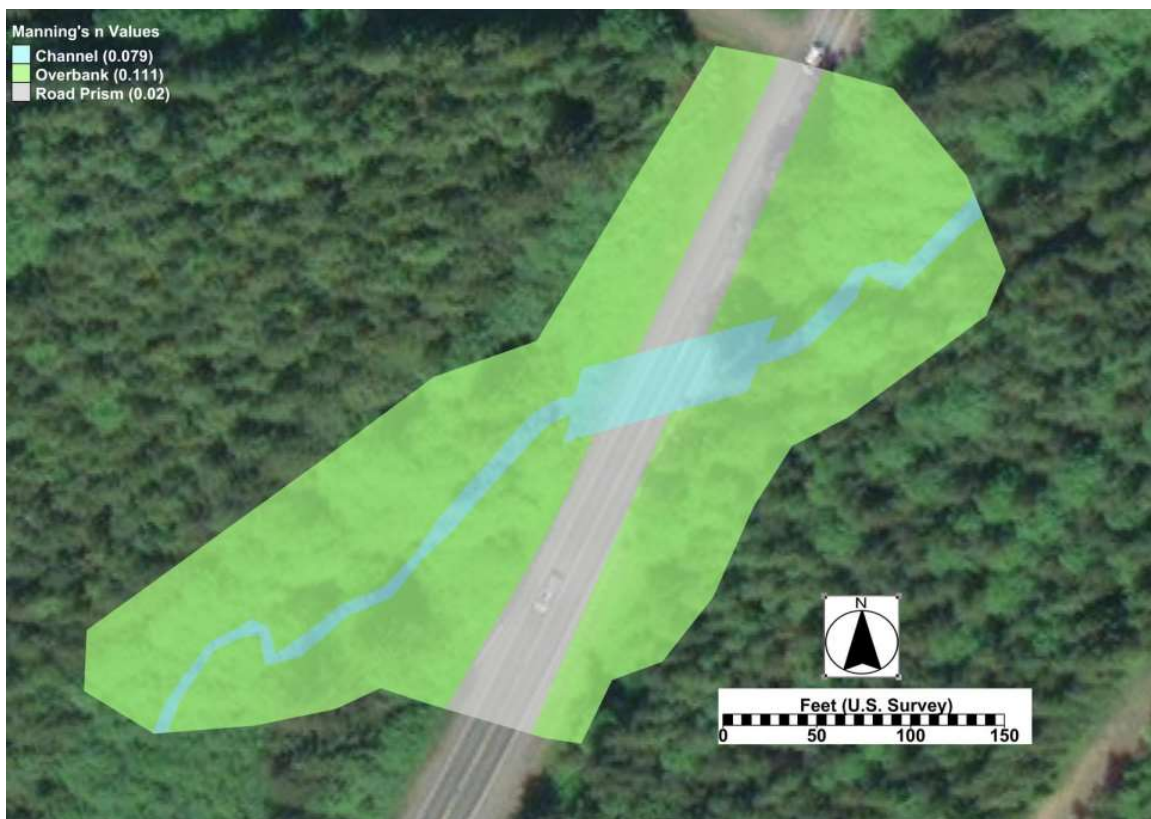
Figure 30: Spatial distribution of roughness values in SRH-2D natural-conditions models

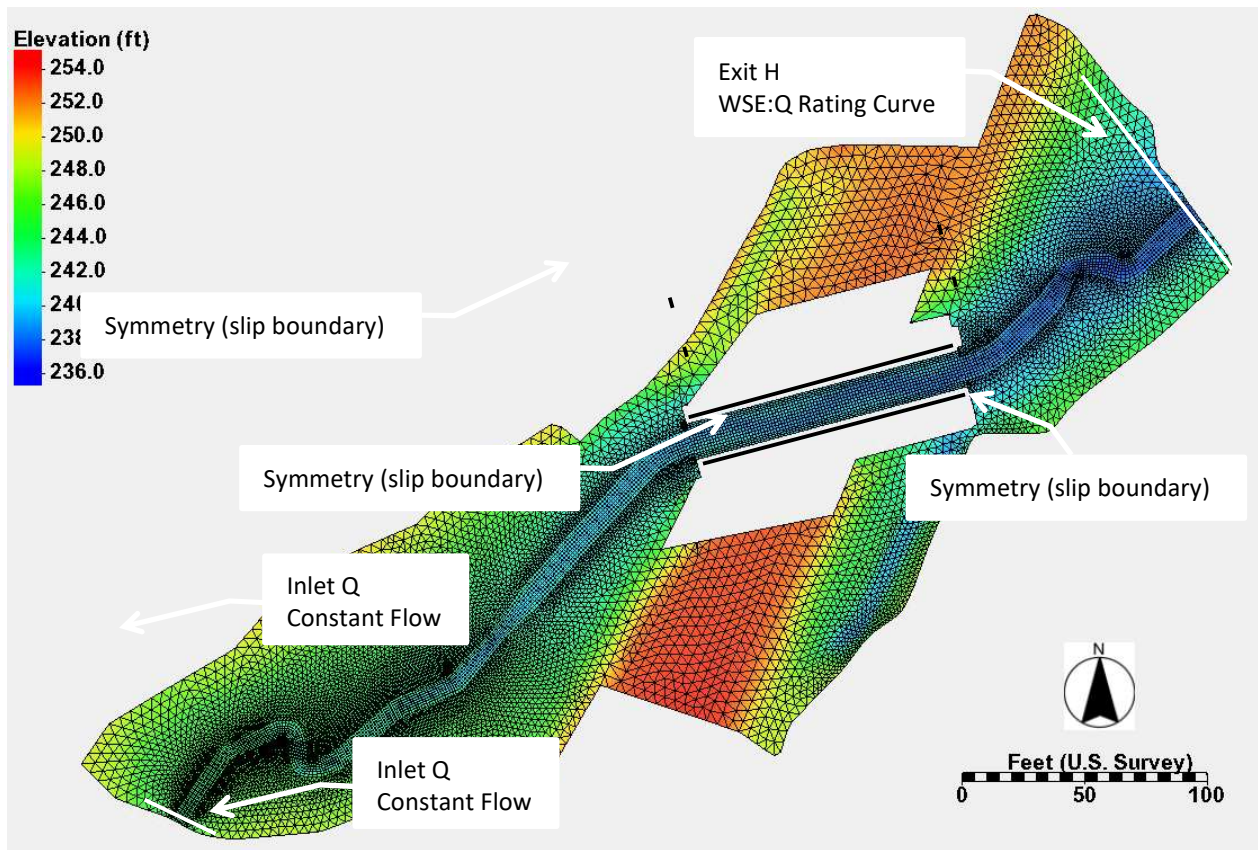
Figure 35: Location of boundary conditions for the proposed-conditions model

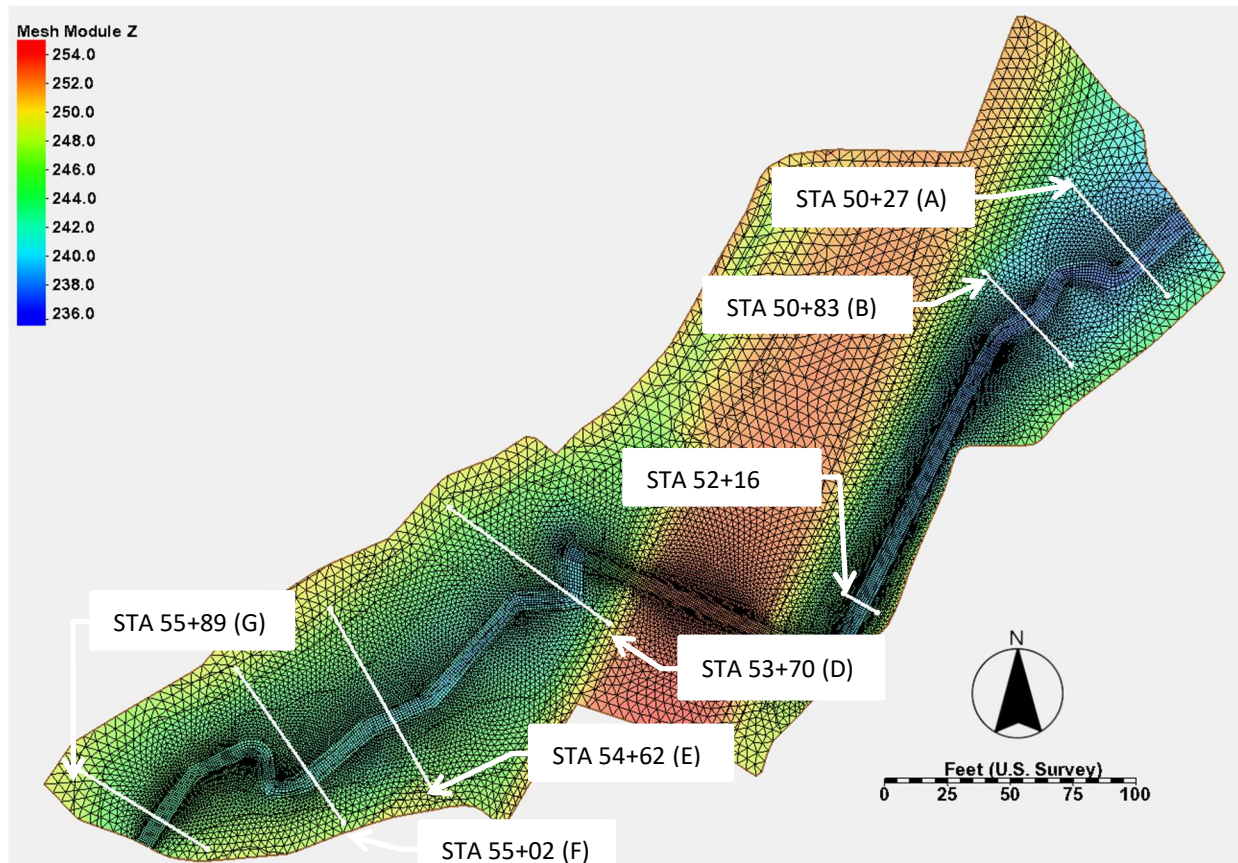
Figure 38: Locations of cross sections used for reporting existing-conditions hydraulic model results

At the upstream cross sections, average velocities for the main channel range from 0.3 foot per second (ft/s) for the 500-year event to 1.8 ft/s for the 2-year event. Downstream velocities range from 1.1 ft/s for the 2-year event to 3.1 ft/s for the 500-year event. Average shear stress values at the upstream cross

sections range from 0.0 pound per square foot (lb/SF) for the 500-year event to 0.6 lb/SF for the 2-year event. Average shear stress values at the downstream cross sections range from 0.2 lb/SF for the 2-year event to 1.6 lb/SF for the 500-year event. Depths at the upstream cross sections range from 1.1 foot at the 2-year event to 7.0 feet at the 500-year event. Depths at the downstream cross sections range from 1.3 foot for the 2-year event to 3.0 feet for the 500-year event.

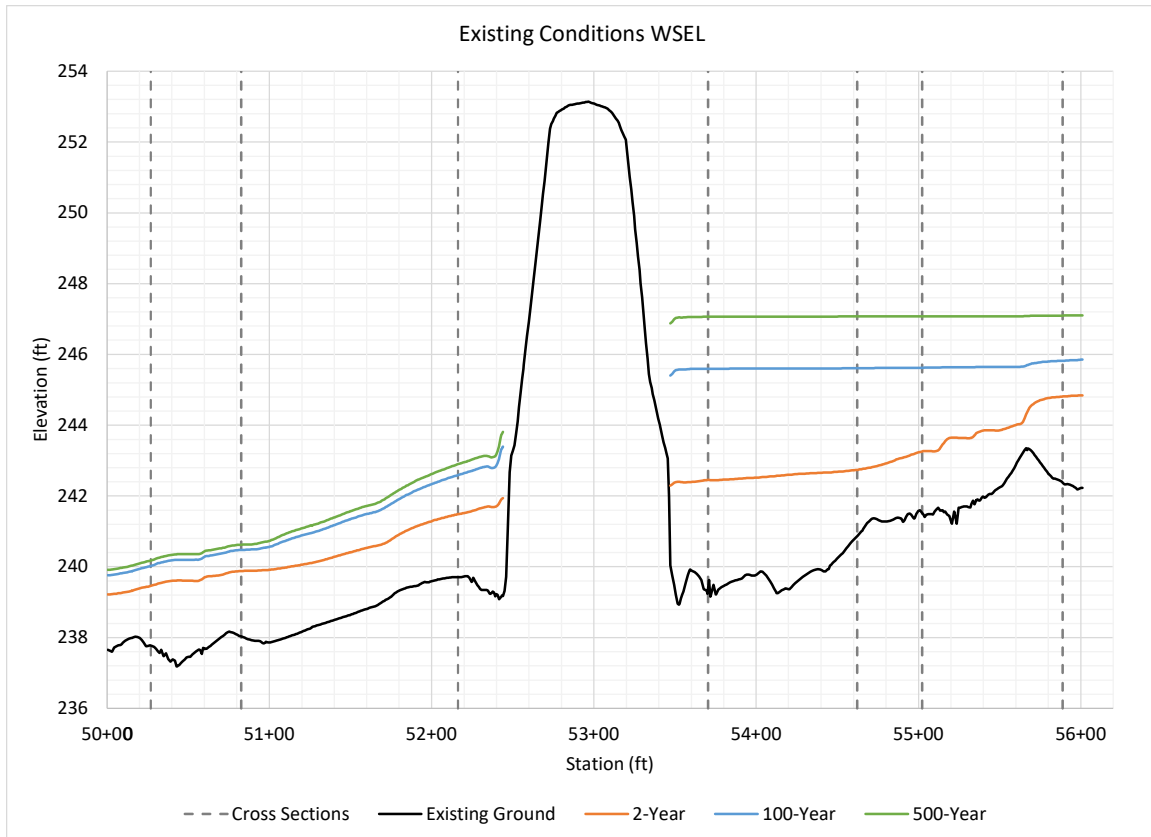
Figure 40: Existing-conditions water surface profiles

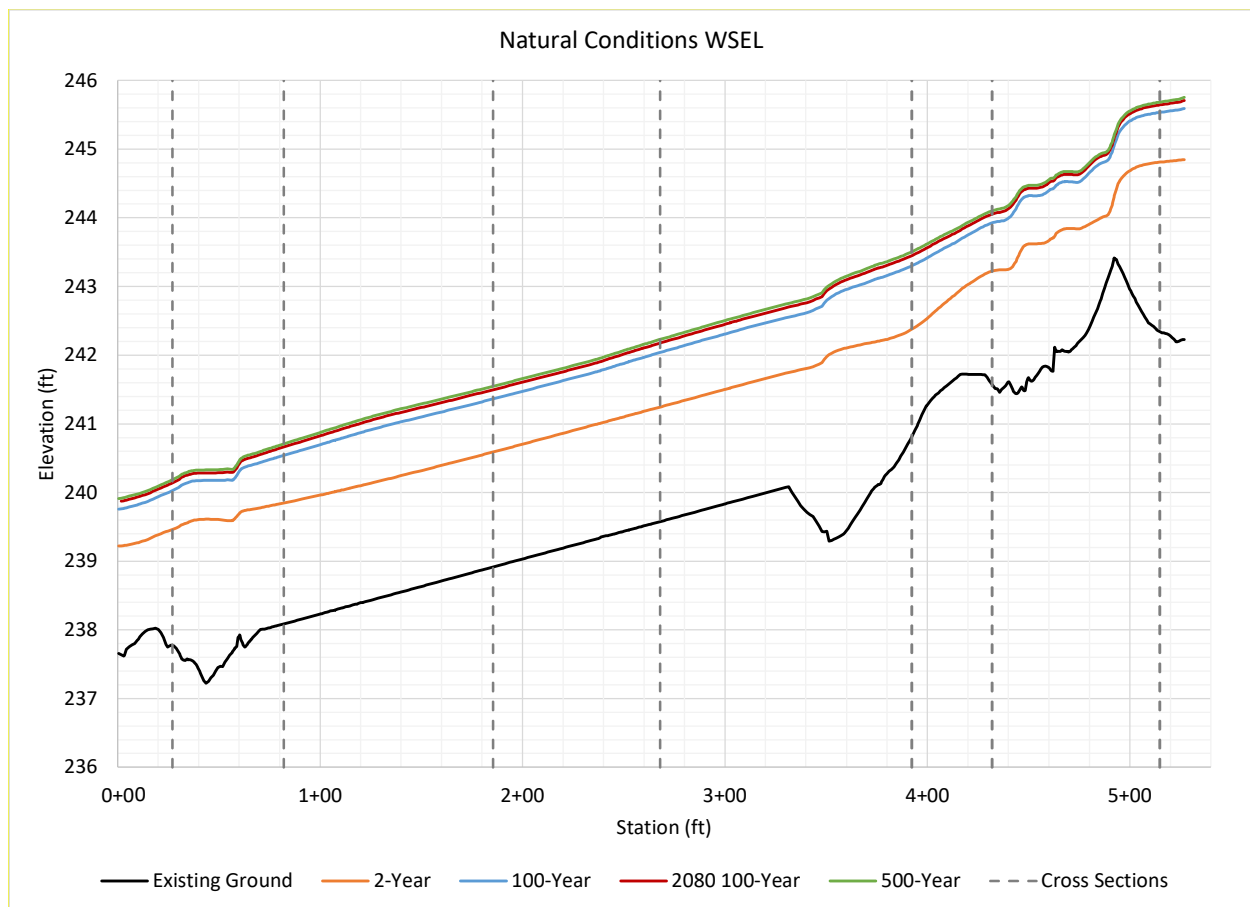
Figure 45: Natural-conditions water surface profiles

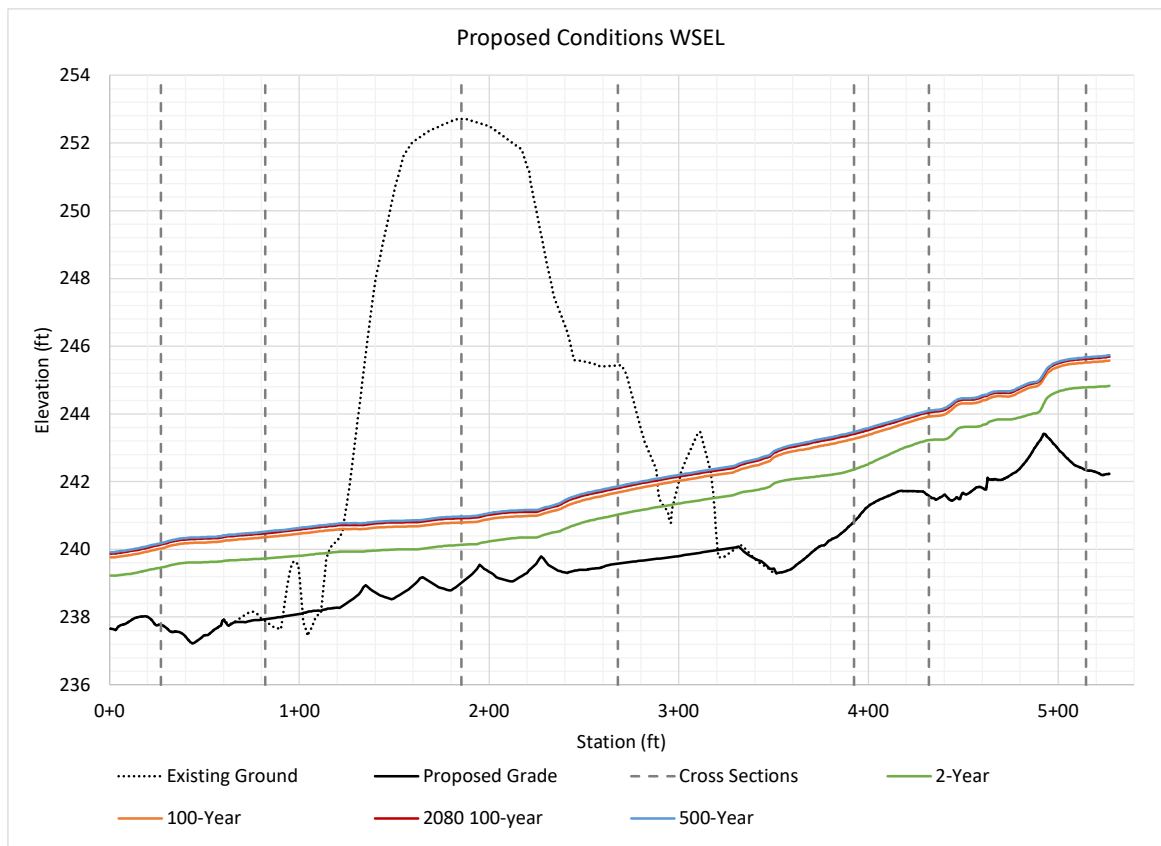
Figure 52: Proposed-conditions water surface profiles

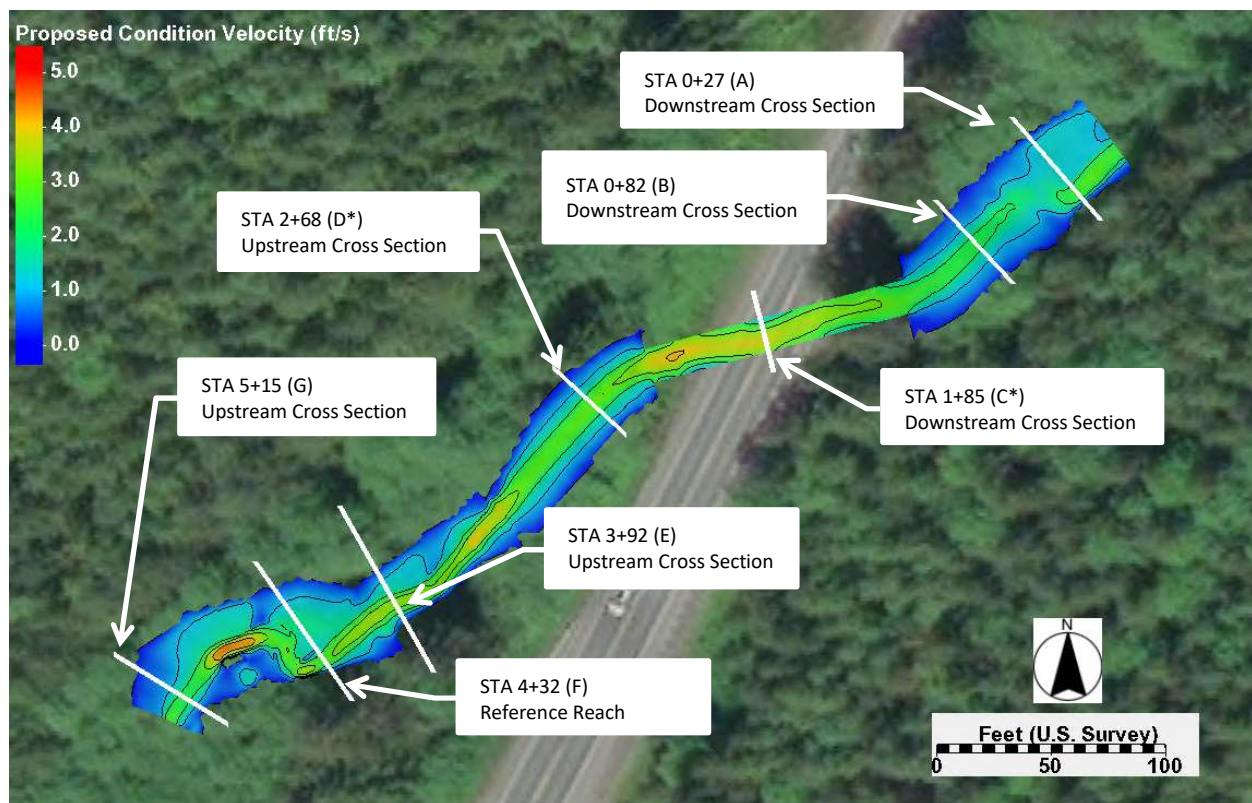
Figure 54: Proposed-conditions 100-year velocity map

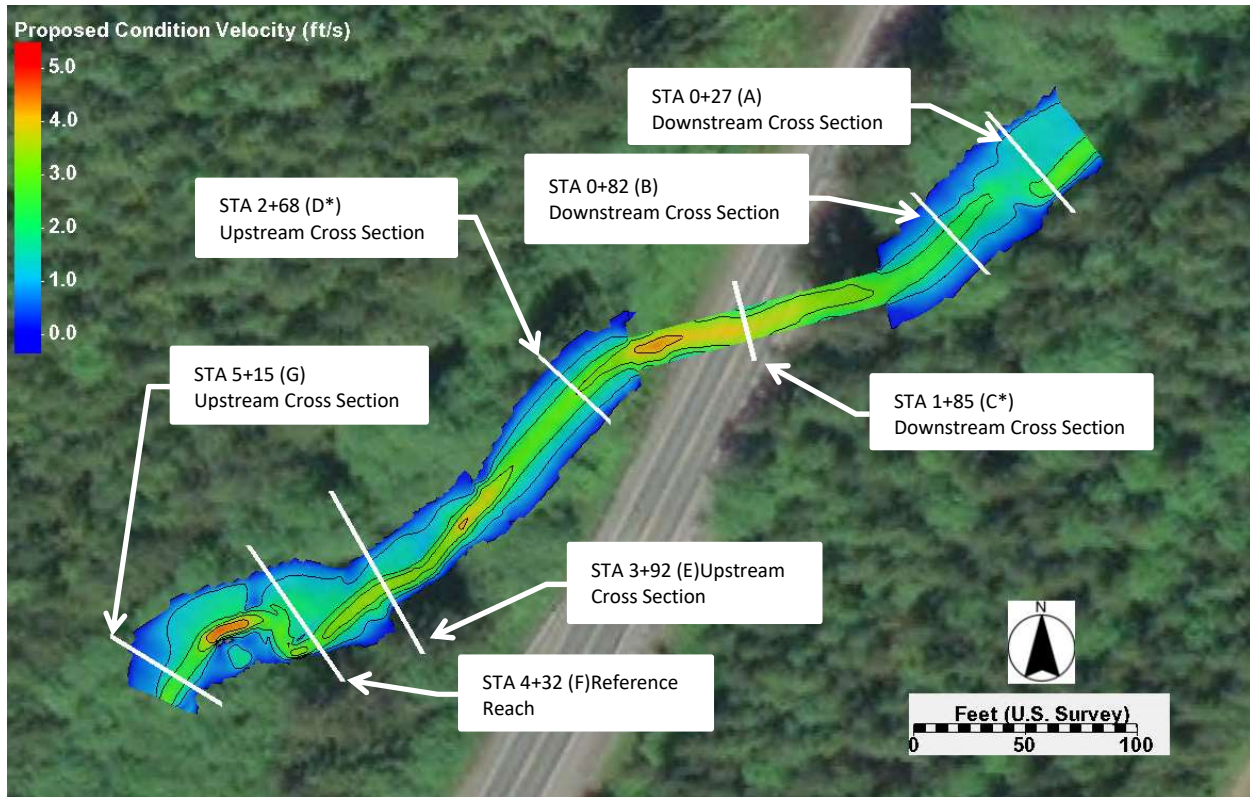
Figure 55: Proposed-conditions 2080 predicted 100-year velocity map

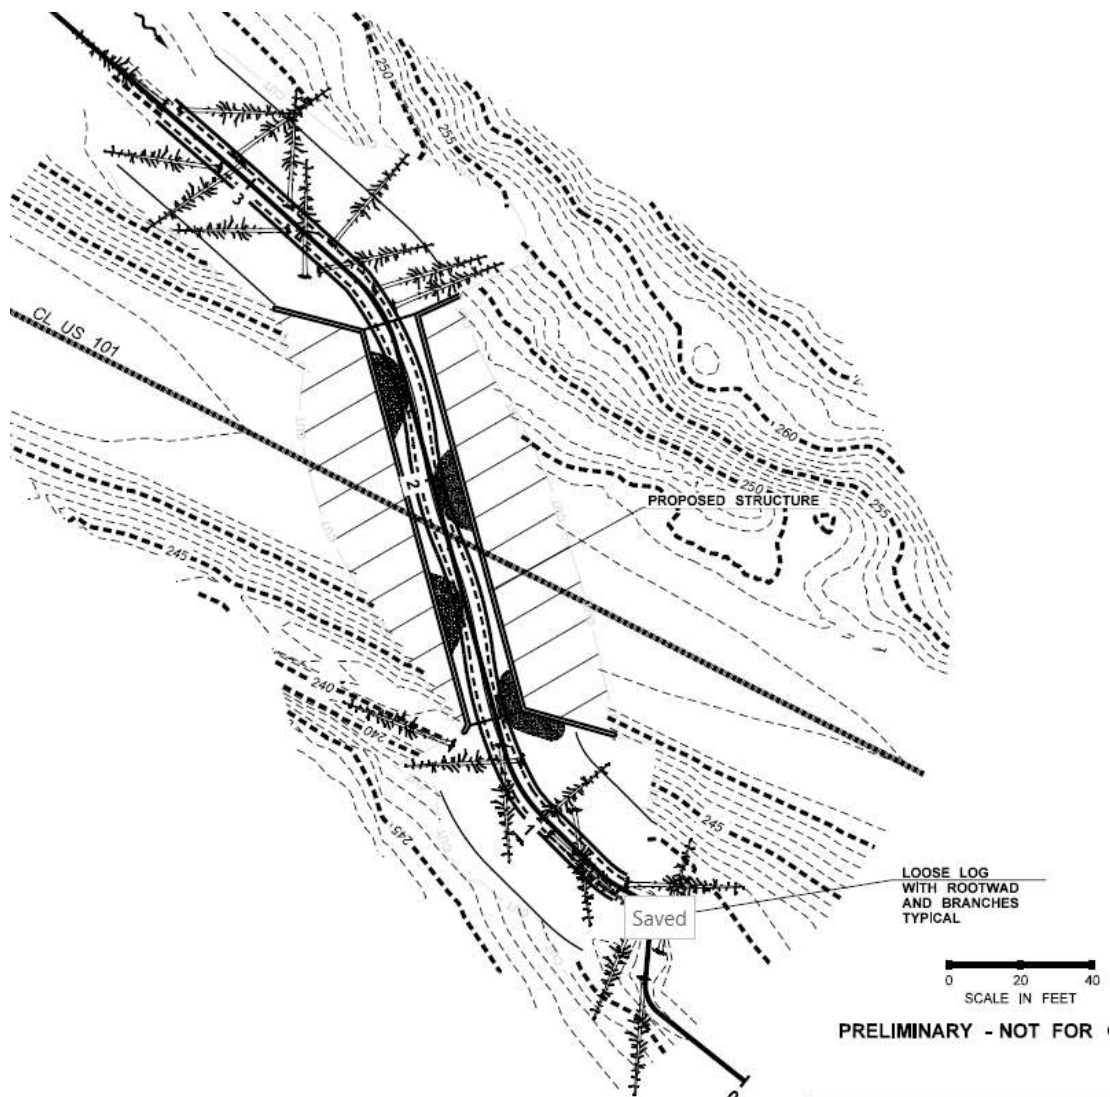
Figure 57: Conceptual layout of key LWM and alternating bars for habitat complexity

Risk of fish stranding during summer flow conditions is minimal because proposed grading directs flow back to the main channel and does not promote isolated pools. Similar to a natural stream system, there is the potential for floodplain pools that create some potential to isolate fish that have entered during high flow events.

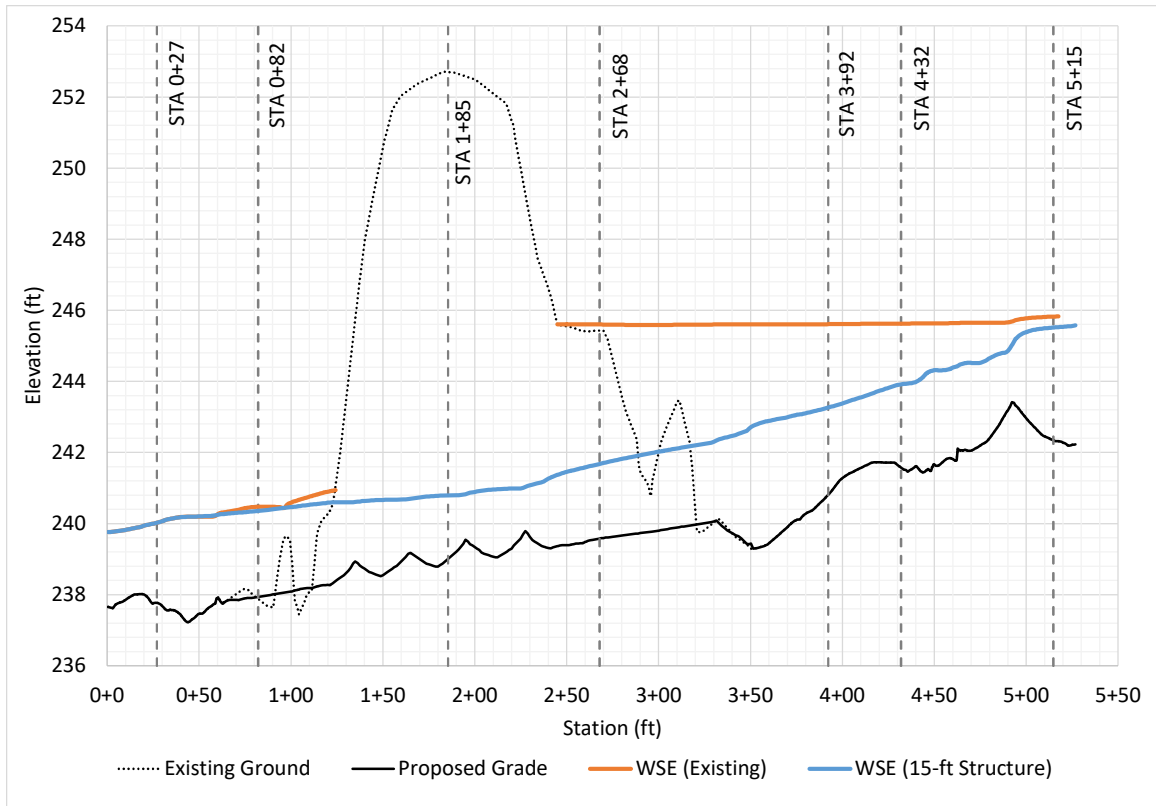
Figure 58: Existing- and proposed-conditions 100-year water surface profile comparison

Downstream of the outlet, the water surface elevation change varies between no change and less than a 0.1-foot rise from the existing to proposed conditions.

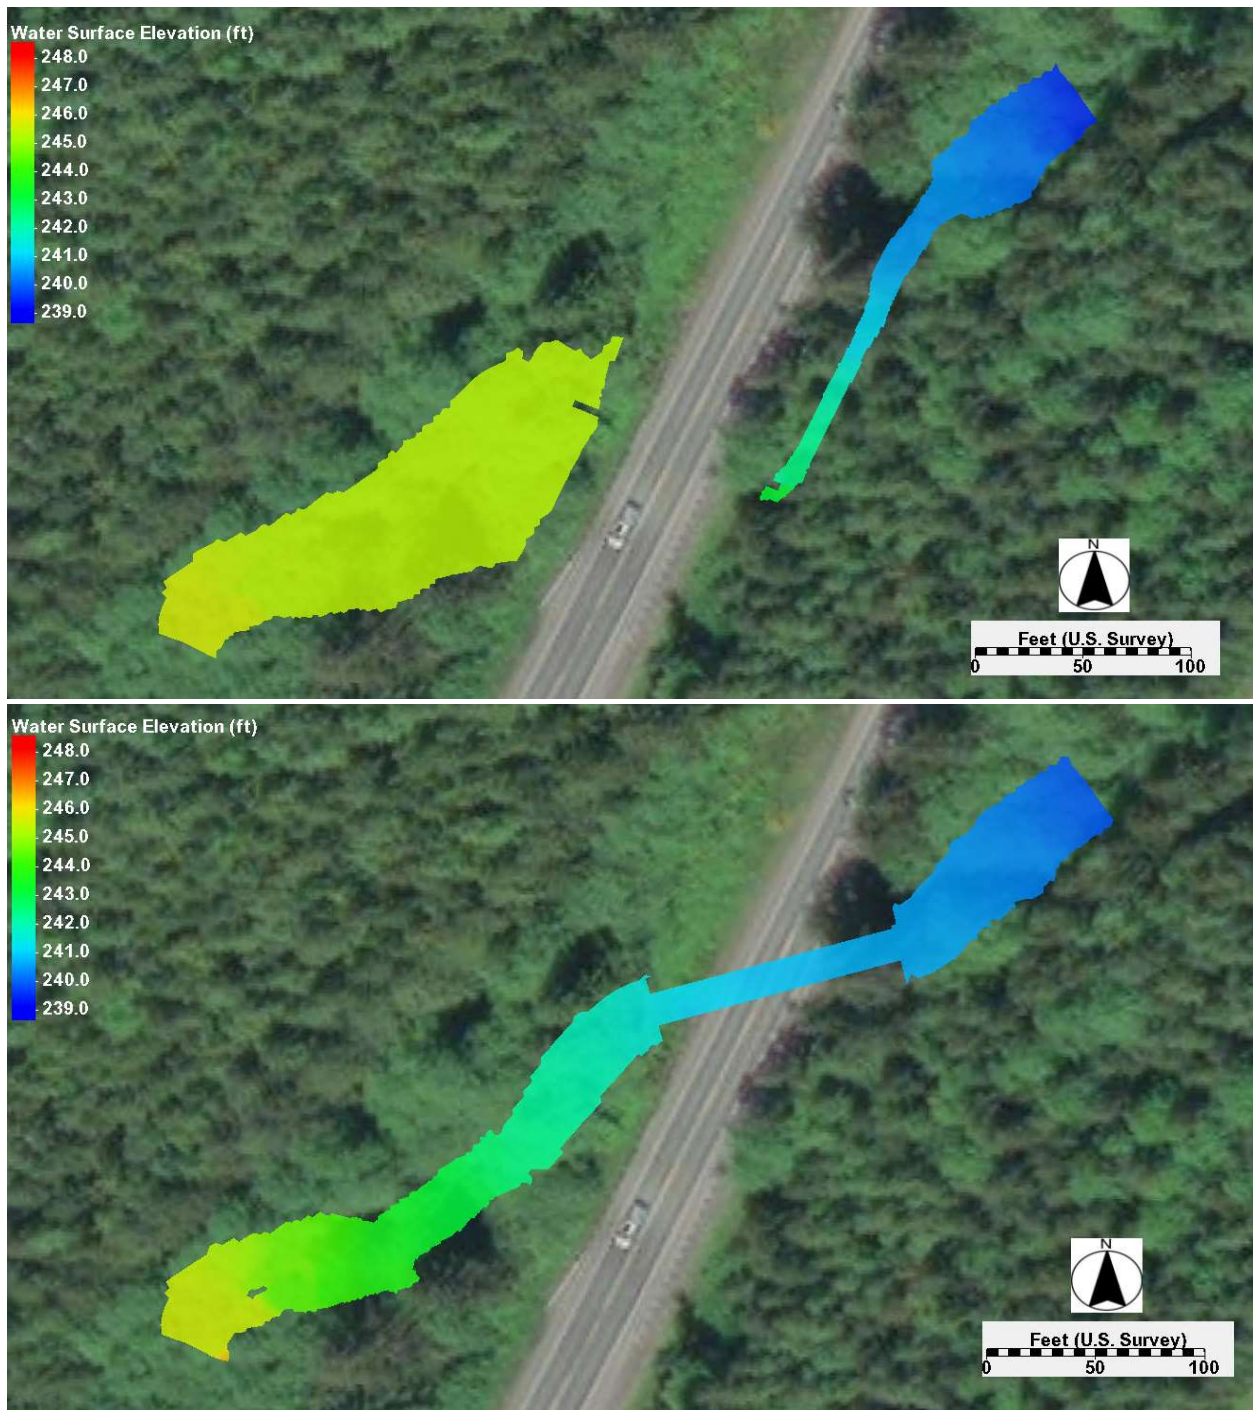
Figure 59: Water surface elevation change from existing (top) to proposed (bottom) conditions

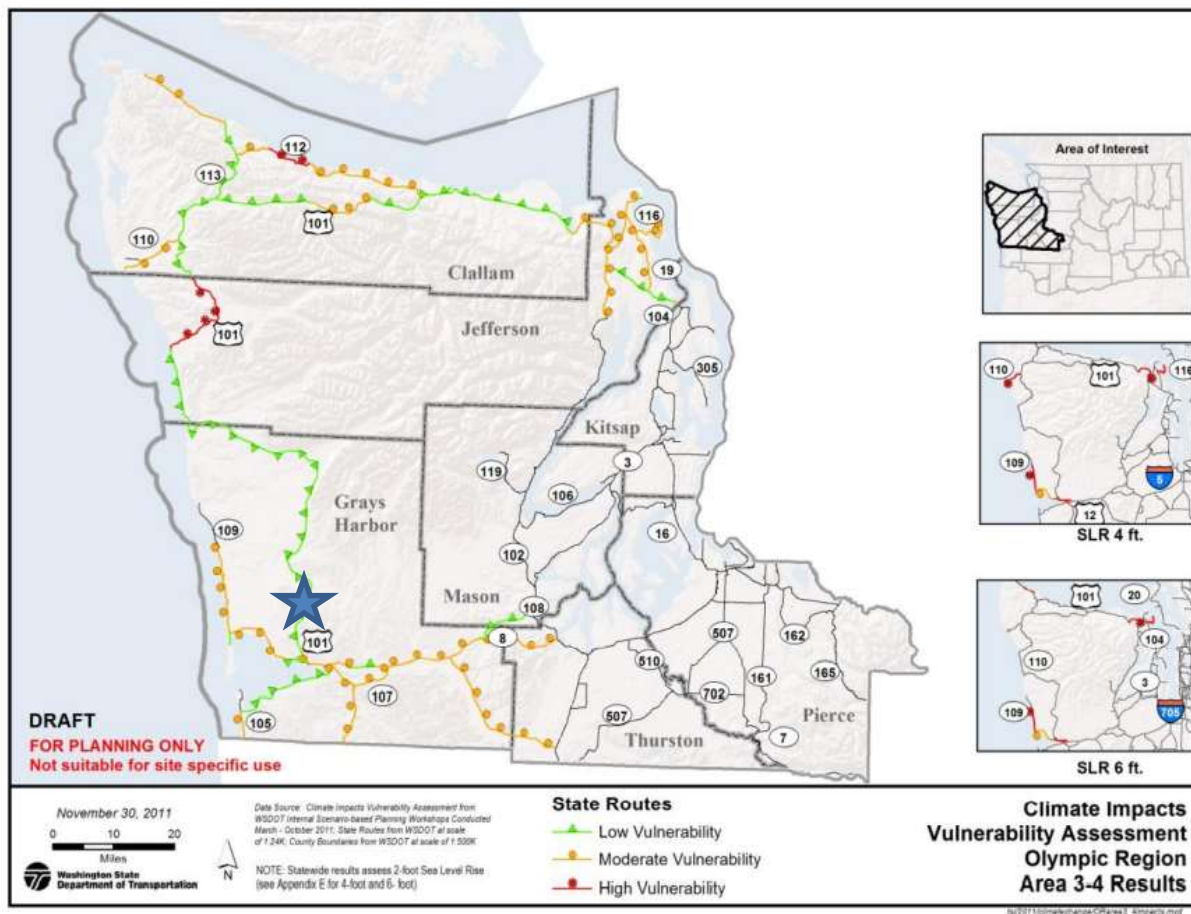
Figure 60: Climate impacts vulnerability assessment of Olympic Region areas 3 and 4 (source: WSDOT 2011). Site location is indicated by star

A minimum hydraulic opening of 13 feet and a minimum maintenance requirement clearance of 6 feet from the channel thalweg to the inside top of structure allows for extreme event flows to pass through the replacement structure safely under the projected 2080 100-year flow event. This will help to ensure that the structure is resilient to climate change and the system is allowed to function naturally, including the passage of sediment, debris, and water in the future.
